To: DeKalb County Public Works Department
Roads and Drainage Division

From: AECOM

Subject: Twin Brothers Lake Dam Alternatives Analysis

Memorandum

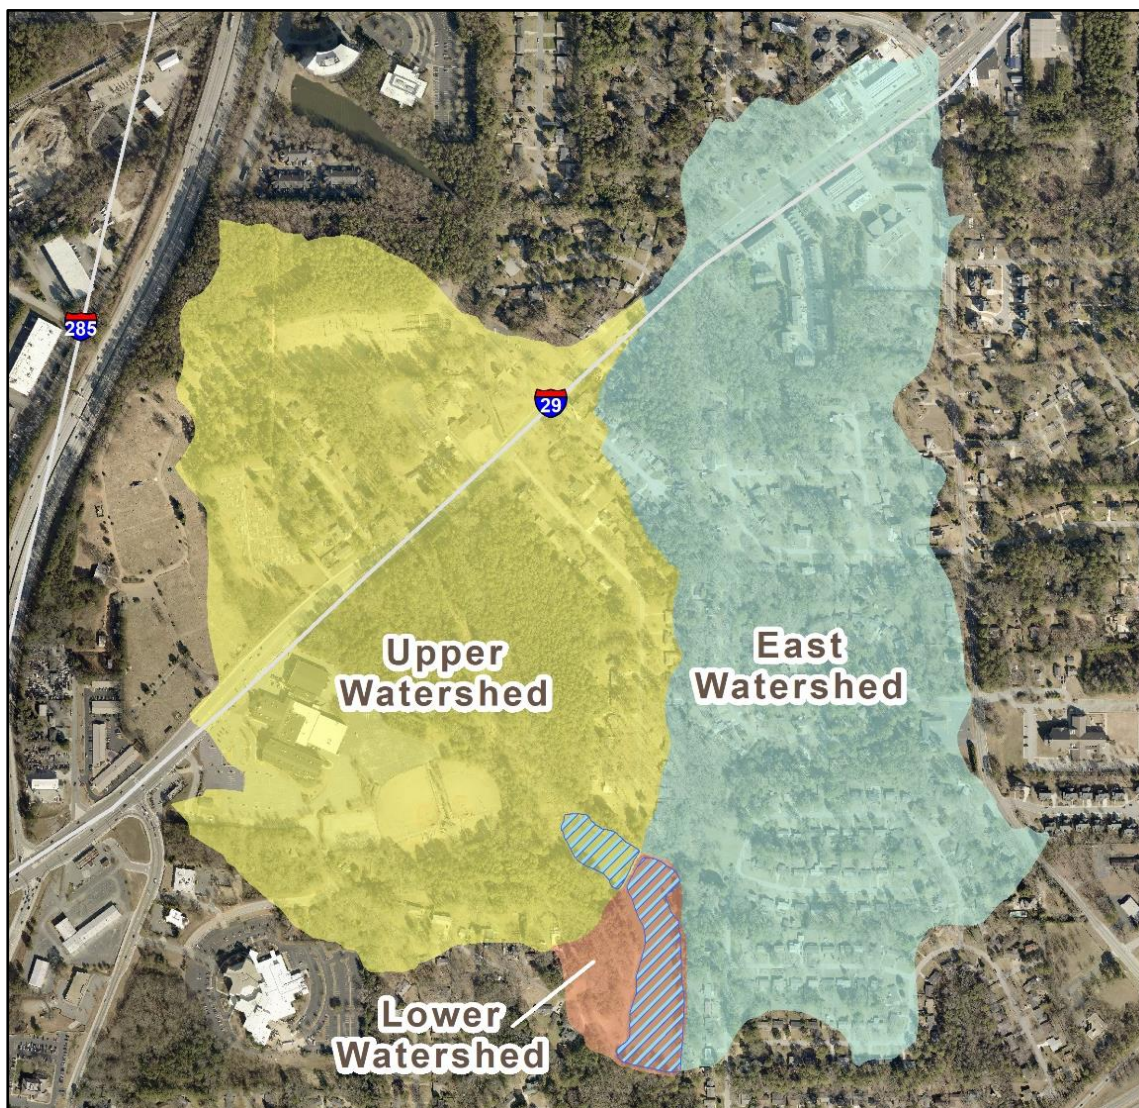
Watershed Name	Area (Acres)
Upper	142.6
Lower	10.1
East	137.3
Total	290.0

Figure 3 Watershed Delineation

Figure 3 illustrates their location.

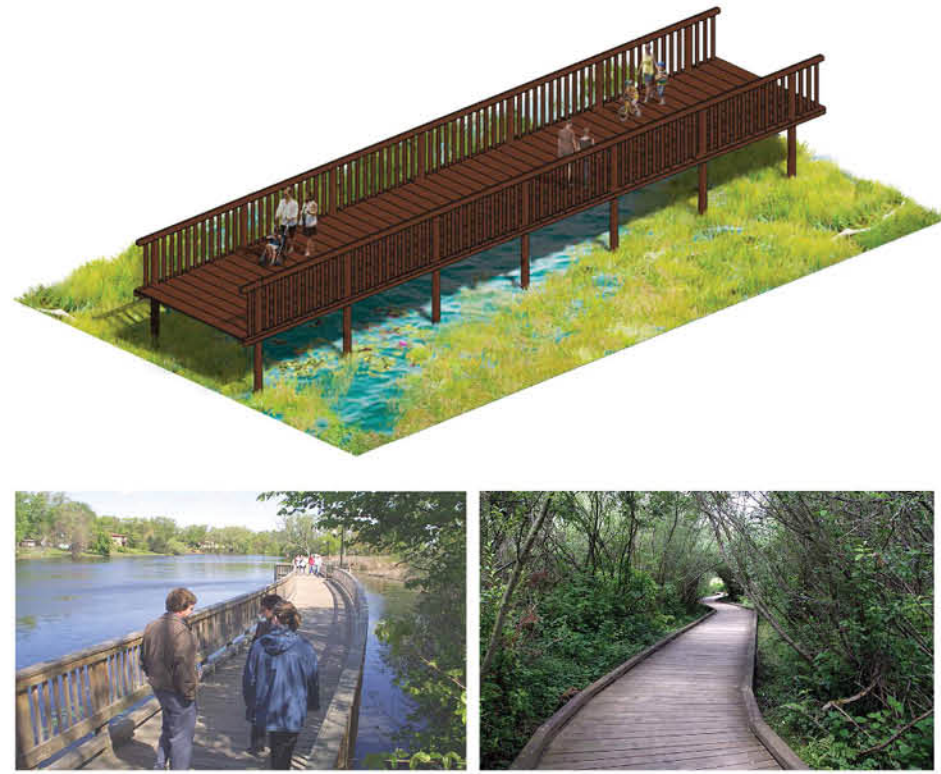
Proposed Boardwalk/ Bridge

- A perpendicular crossing helps to minimize impacts on the restored stream and its ecologically sensitive areas.
